MILL CREEK SURVEY

MARTIN MANER, P.E., DEPT. OF POLLUTION CONTROL AND ECOLOGY

DAVID MOTT, HYDROLOGIST, BUFFALO NATIONAL RIVER

NOVEMBER, 1991

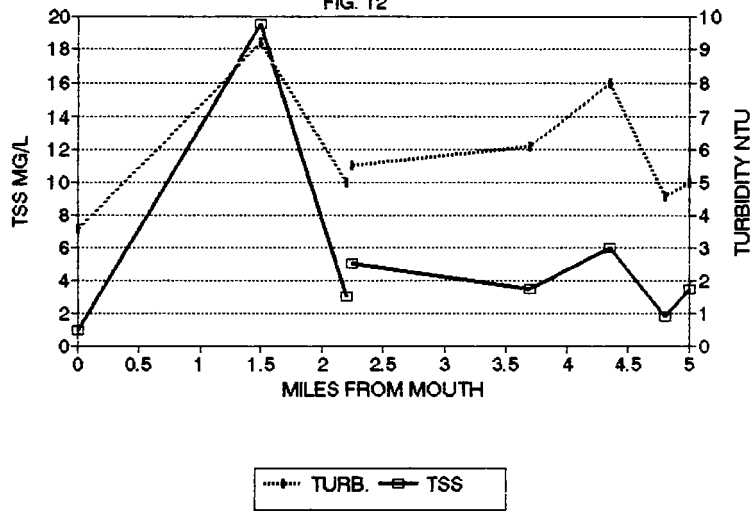
FIG. 12

Total suspended solids and turbidity were low from the Dogpatch Springs but increased through the Dogpatch complex. At the last

dam, the turbidity had reached 8 NTU - the standard is 10 NTU. Total suspended solids and turbidity decreased from the dam site downstream to Spring Valley Road and Harp Creek, but were still at or above the values observed at the Dogpatch Springs. Values dropped slightly with the inflow of Harp Creek but increased to the instream maximums just above Flat Rock Creek. This is just downstream of the old lake bed. The increase at this point is probably due to fine sediment being re-suspended and eroded as the creek flows through the old lake bed site.

MILL CREEK TURBIDITY AND TSS

Bank stabilization should be implemented throughout the length of this segment and all bare, unvegetated areas should be planted with adequate cover to prevent erosion.

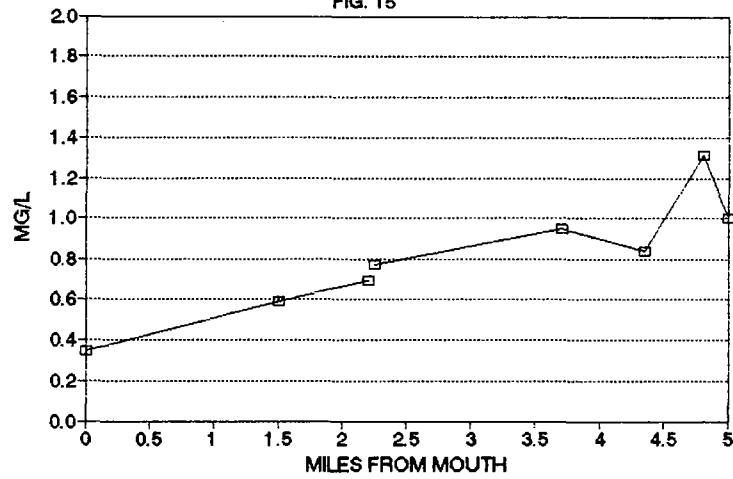
MILL CREEK
NITRITE - NITRATE CONCENTRATION
FIG. 15

Nitrite-nitrate values in the springs feeding Mill Creek are high. The level at Highway 7 was 1.00 mg/l and at Dogpatch spring 1.46 mg/l. Nitrate levels decrease from these levels to the mouth, where the level was 0.35 mg/l. Mill Creek was contributing greater than 96% of the nitrite-nitrate load carried by the Buffalo River below their confluence at the time of the survey. This is the single most significant impact Mill Creek is having on the Buffalo.

The recharge area of the two springs at Dogpatch should be identified to the extent possible. Field reconnaissance within this area should then be done to identify potential nitrogen sources or land use practices which could introduce nitrite-nitrate nitrogen to the spring recharge area. Best management practices, such as development of nutrient management plans for agricultural operations as prepared by the Soil Conservation Service, should be implemented where feasible.

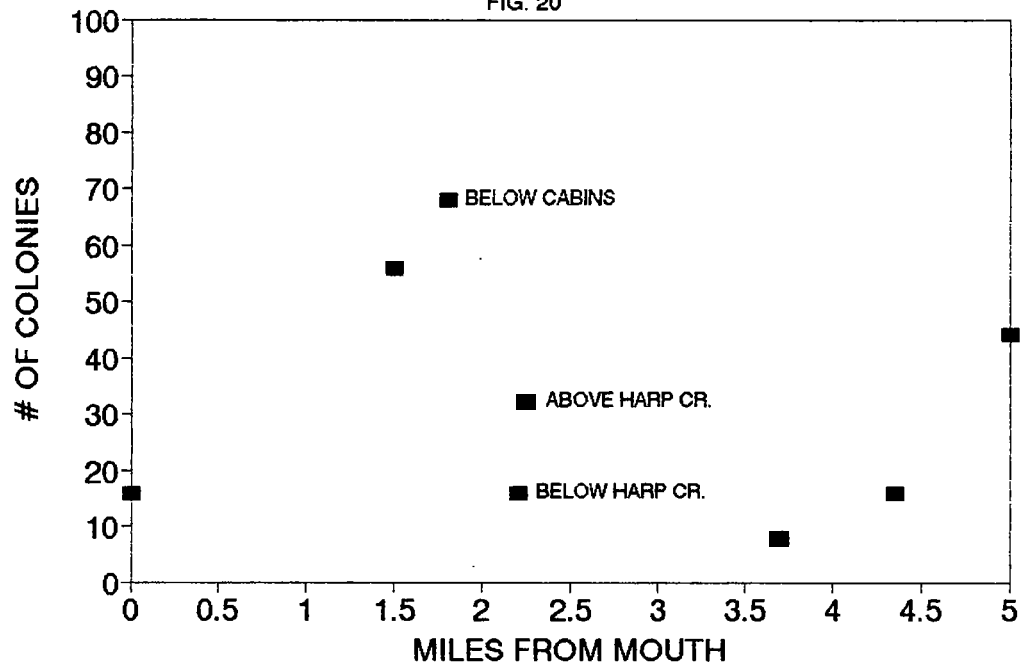
FIG. 20

Fecal coliforms were 44 colonies/100 ml at the Highway 7 bridge, decreasing as the creek flowed through the Dogpatch complex, reaching the minimum value of 8 colonies/100 ml at Spring Valley Road . Values jumped up to 68 colonies/100 ml below the cabins along Mill Creek and then declined to 16 colonies/100 ml at the mouth.

MILL CREEK FECAL COLIFORM

Onsite evaluation of the domestic household septic tank systems adjacent to Mill Creek (say 200 yds) should be conducted to see if the systems are operating properly. That is, no surfacing of effluent, leaking systems, or direct discharges should exist.
